TOWN BOARD OF THE TOWN OF LIBERTY-SPECIAL MEETING FOCUS MEDIA
120 NORTH MAIN STREET, LIBERTY, NEW YORK 12754
JUNE 27, 2016
7:00 P.M.

Mr. Peter Connery and I conducted a routine inspection of the Paramount Pond Dam, an intermediate hazard dam, on June 16, 2016 as part of the Department of Environmental Conservation's (Department) ongoing Dam Safety program. I am writing you as it is my understanding that you are or represent the owner of Paramount Pond Dam. A copy of the inspection report is enclosed.

***INSPECTION AND CLEANING (SEDIMENT REMOVAL) OF THE WHITE
SULPHUR SPRINGS 300,000-GALLON WELDED STEEL WATER
STORAGE TANK***

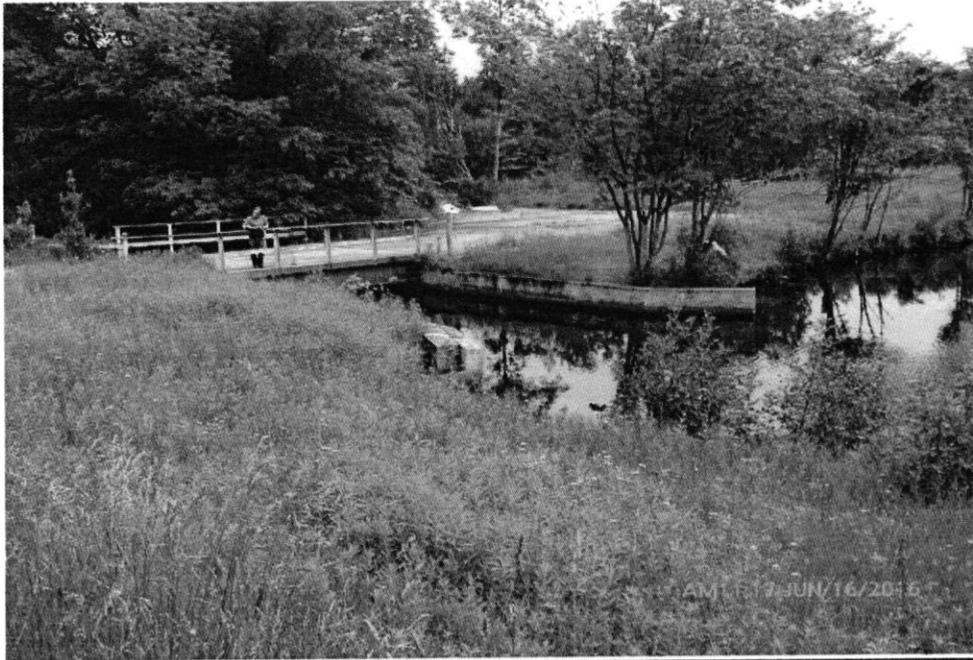
Photo 1 Dam ID# 162-1283 Paramount Pond Dam 06/16/2016
Service spillway's inlet section and dam's upstream embankment as observed from the left upstream bank.

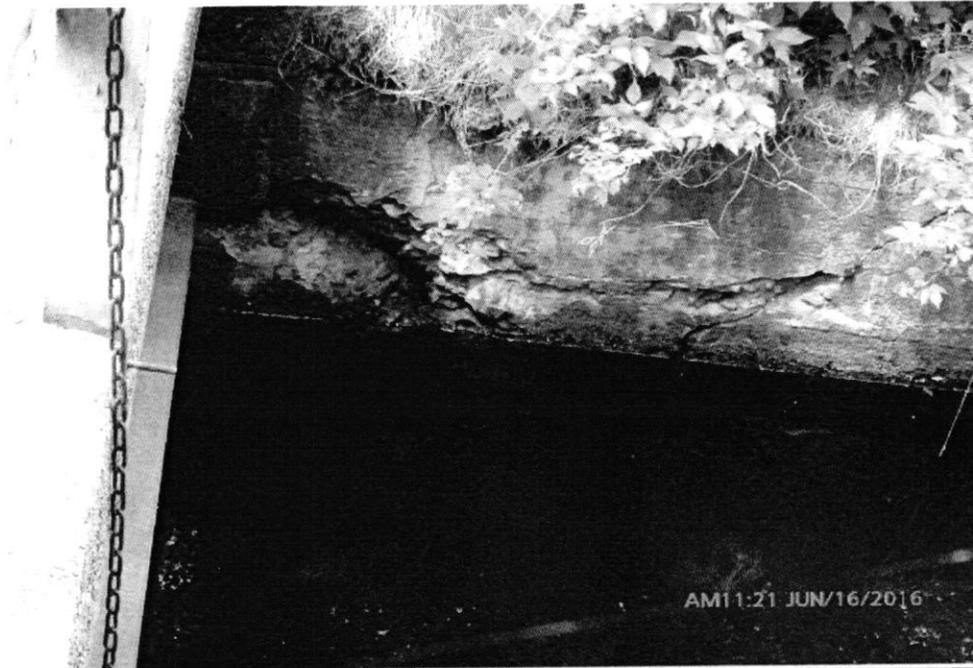
- The spillway's left and right training walls continue to be deteriorated, i.e., cracked concrete, voids in the walls, and the left upstream training wall was noticed to be tilting into the spillway's channel. A restoration of the spillway should be considered.

Photo 2 Dam ID# 162-1283 Paramount Pond Dam 06/16/2016
Deteriorated concrete on service spillway's left upstream training wall as observed from the downstream side of the bridge that spans the spillway.

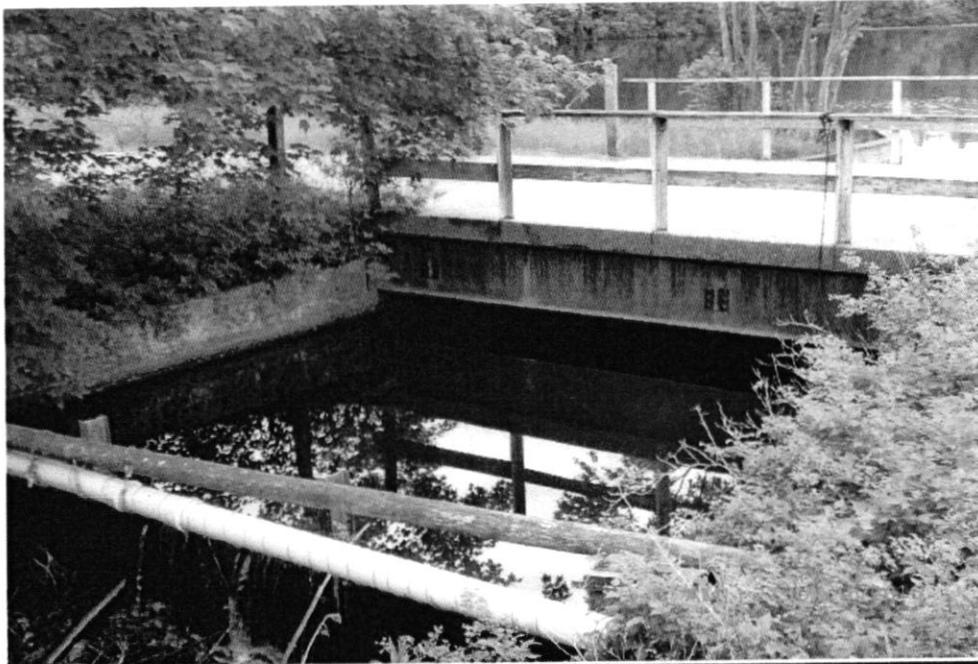
Photo 3 Dam ID# 162-1283 Paramount Pond Dam 06/16/2016
Service spillway as observed from the left downstream side.

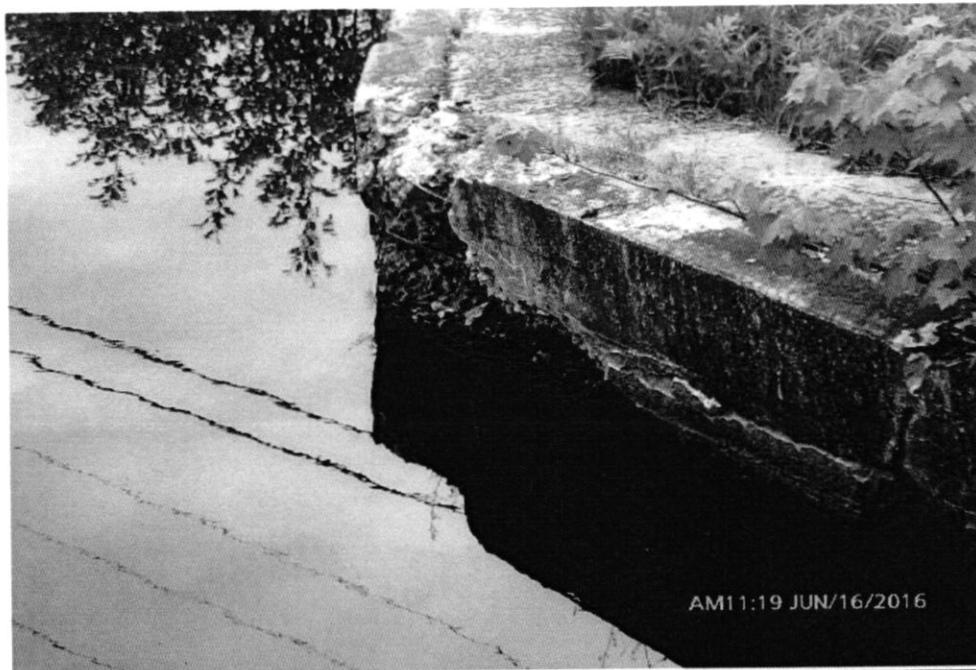
- Section of the left spillway training wall is tilting into the channel.
- Left training wall has cracks, voids and exposed reinforcing bars.
- Right training wall has concrete deterioration and cracks.
- Stop logs spanning across a portion of the spillway weir section.

Photo 4 Dam ID# 162-1283 Paramount Pond Dam 06/16/2016
Deteriorated concrete and exposed reinforcing bars on the service spillway's left upstream training wall as observed from the bridge that spans the spillway.

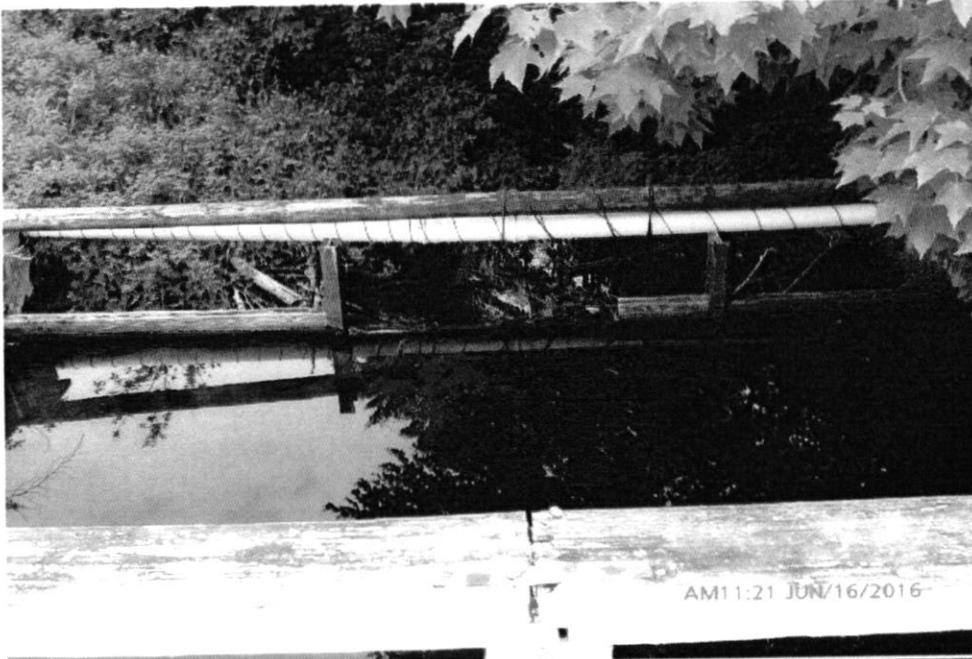
Photo 5 Dam ID# 162-1283 Paramount Pond Dam 06/16/2016
Primary and secondary spillways as observed from the bridge that spans the spillway.

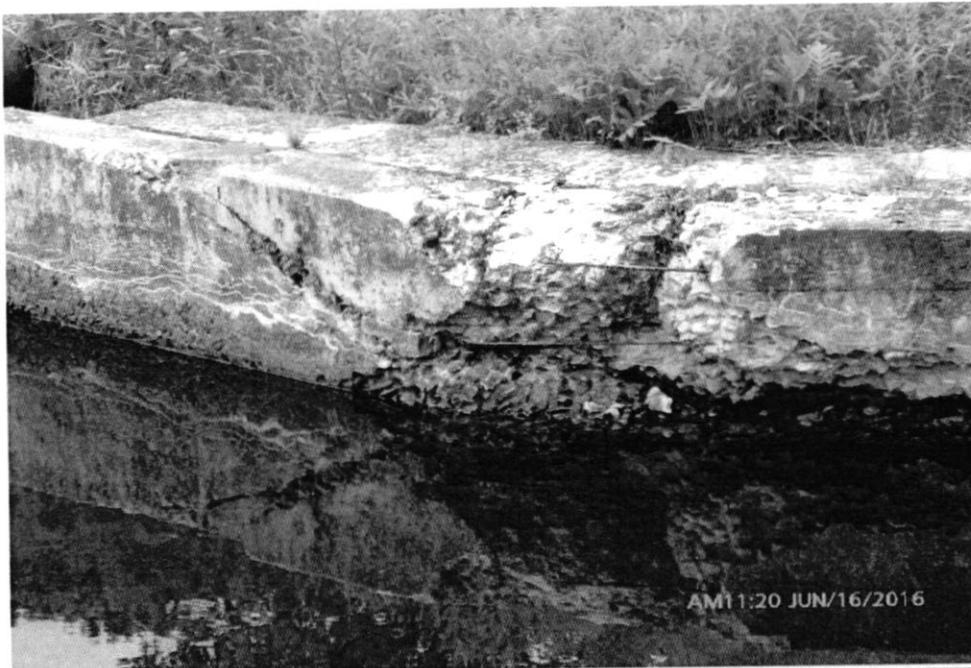
Photo 6 Dam ID# 162-1283 Paramount Pond Dam 06/16/2016
Deteriorated concrete and exposed reinforcing bars on the service spillway's left upstream training wall as observed from service spillway's right side

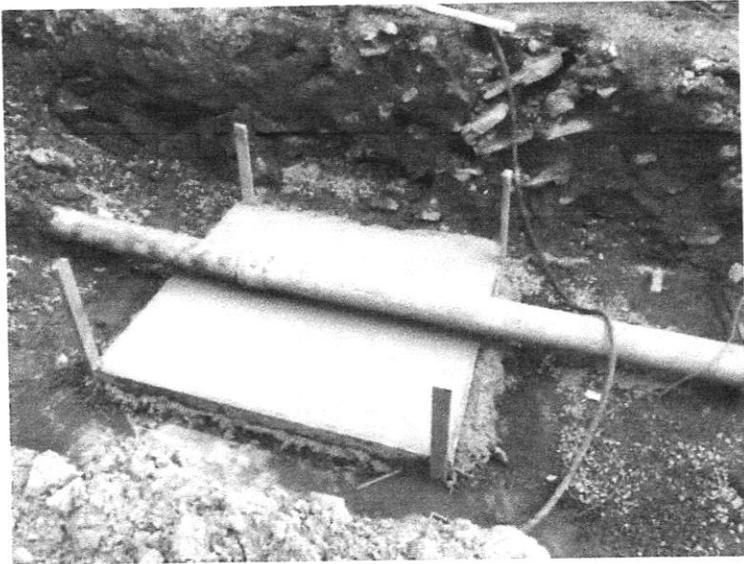
Freshly poured slab – Picture taken May 16, 2016

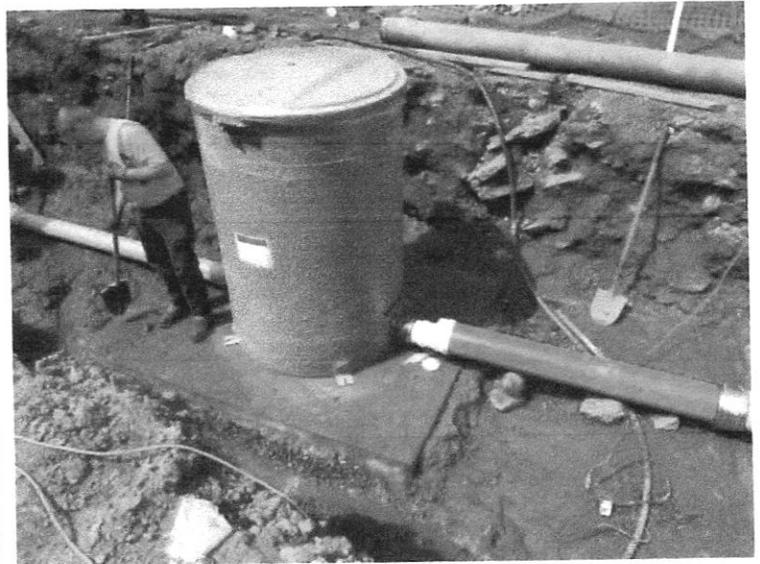
Manhole set on slab prior to bolting down – Picture taken May 17, 2016

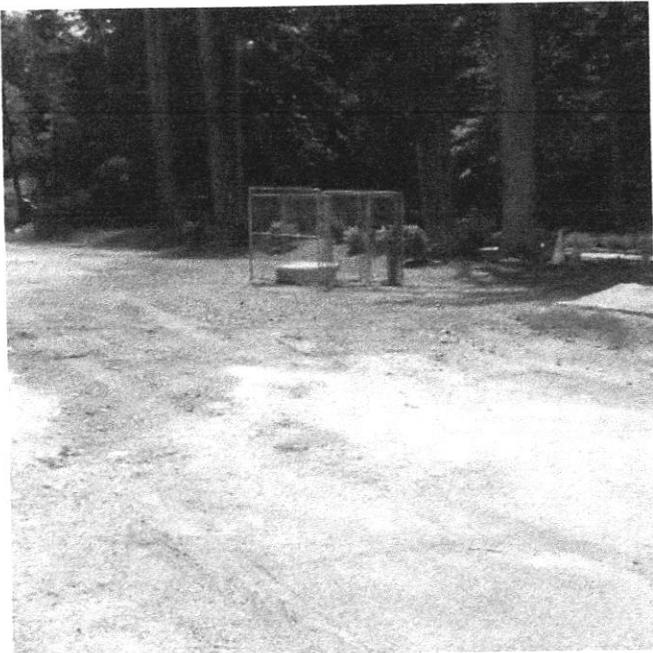
Manhole backfilled and restored with temporary fencing around it.
– Picture taken June 21, 2016

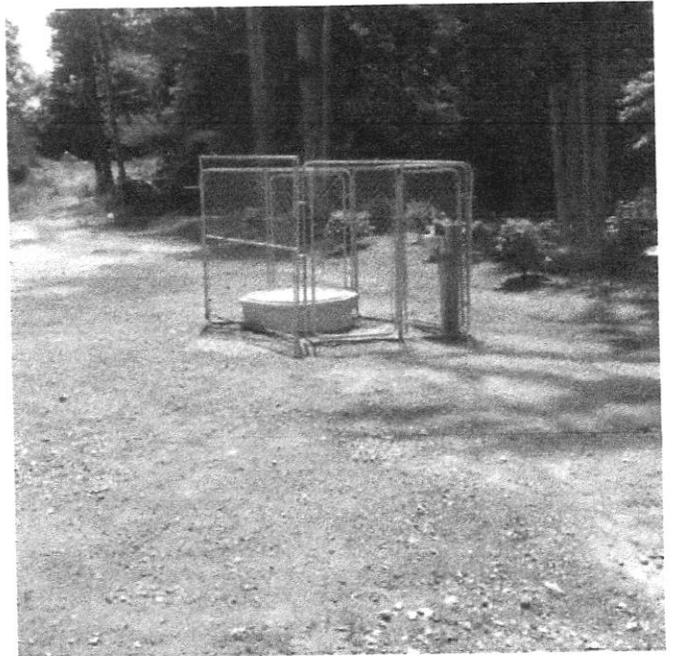
Manhole backfilled and restored with temporary fencing around it. – Picture taken June 21, 2016

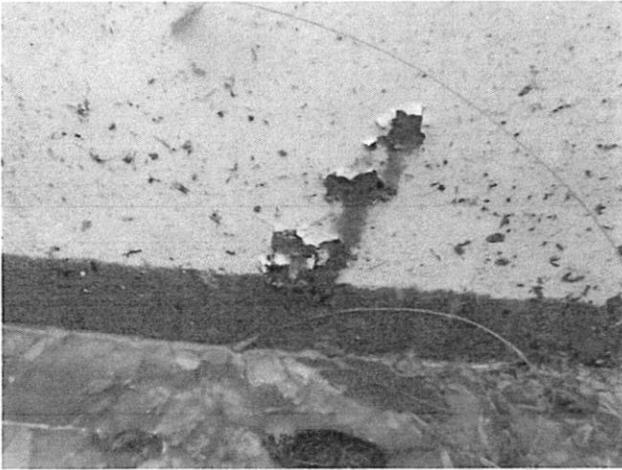
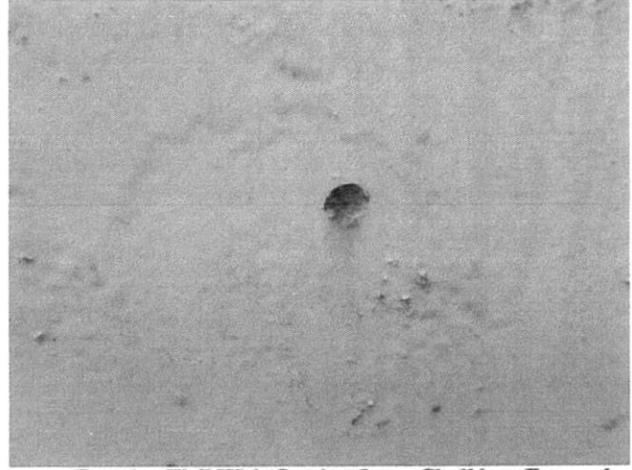
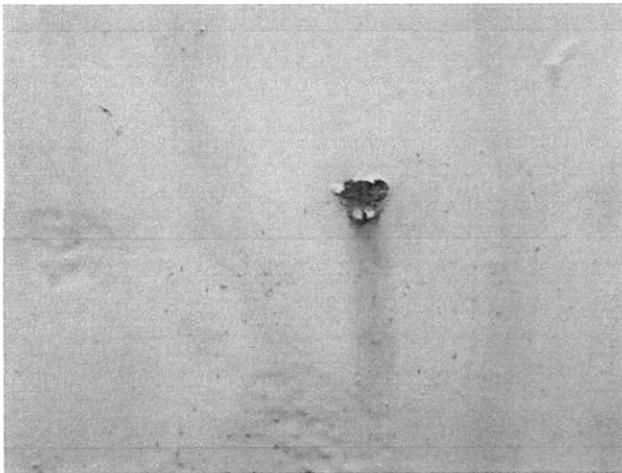
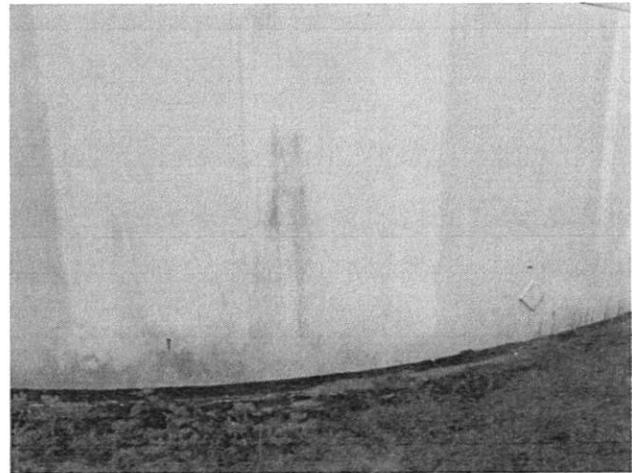
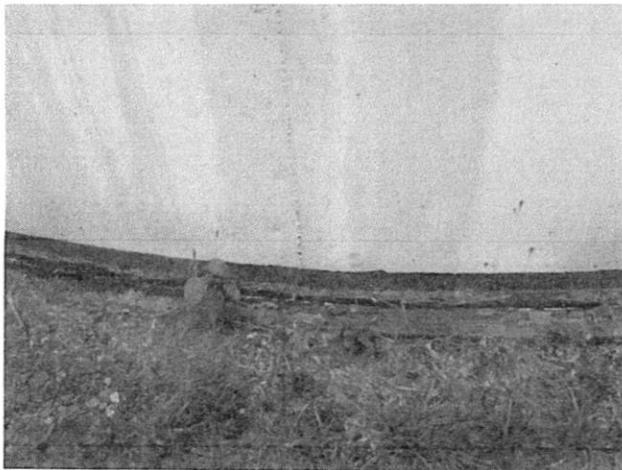
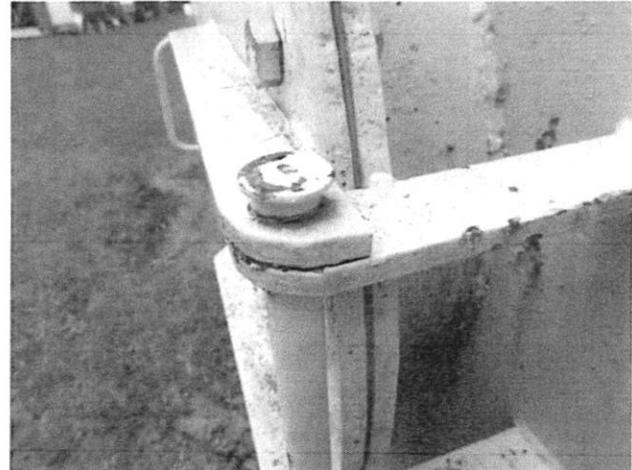
The protective coating applied to these welded steel surfaces is chalking due to weathering, yet remains having mostly good adhesion value. Several isolated areas of coating loss and steel exposure were observed throughout less than 5% of the lowest row of wall panels.

No obvious fatigue (pitting) of the steel was evident within these 1/4" to 1" diameter areas of steel exposure, rather mild surface corrosion exists at this time.

1 *Exterior Wall With Coating Loss, Chalking, Exposed Steel, Mild Surface Corrosion And Mild To Moderate Mildew*

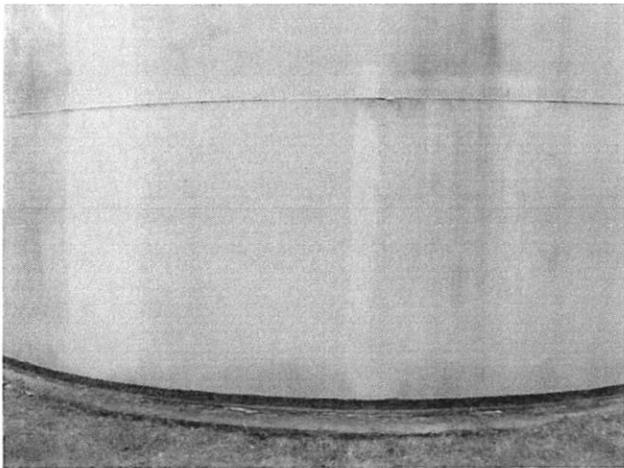
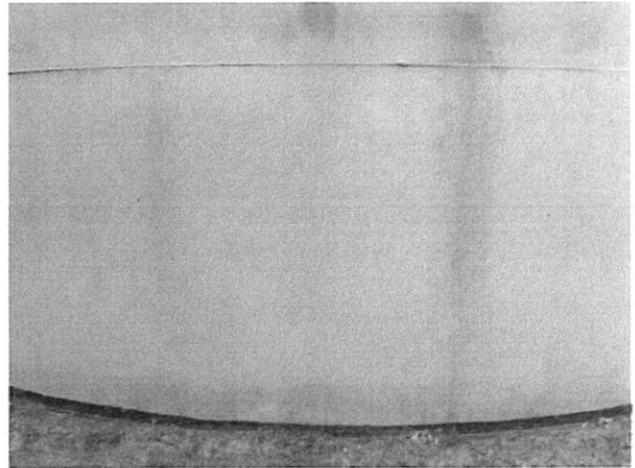
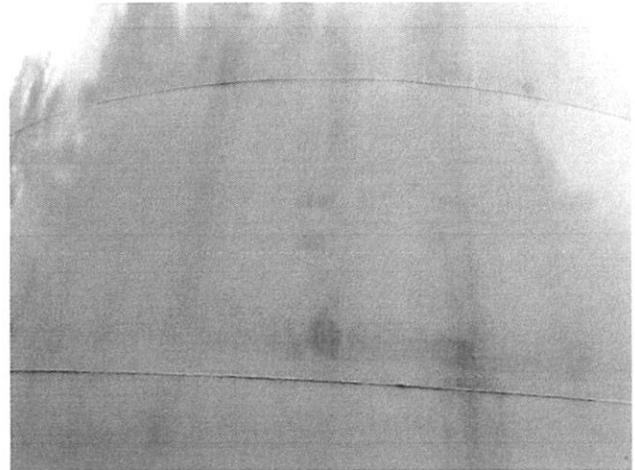
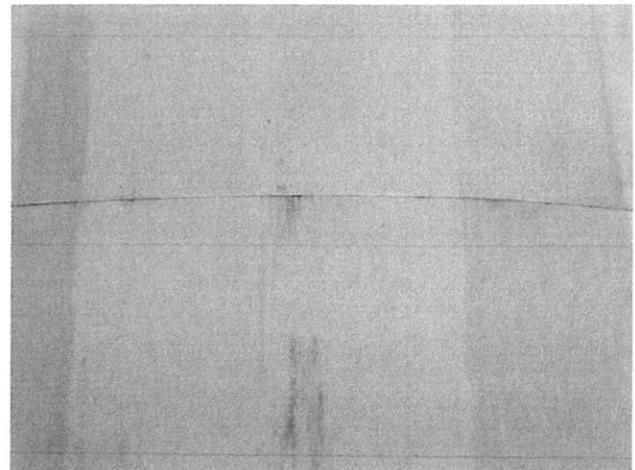
7 *Exterior Wall With Mild To Moderate Mildew*

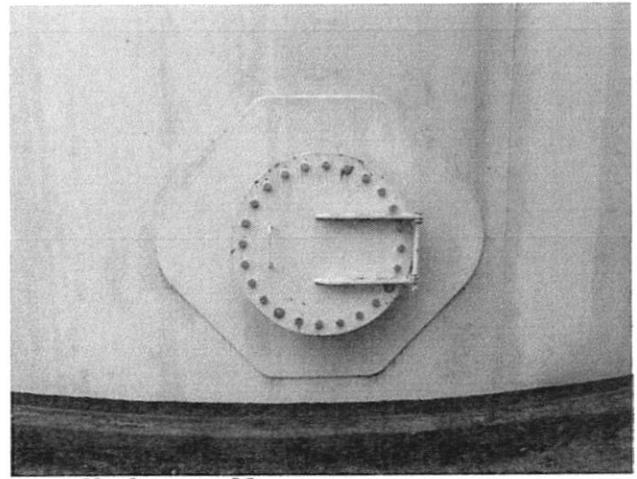
16 *Northernmost Manway*

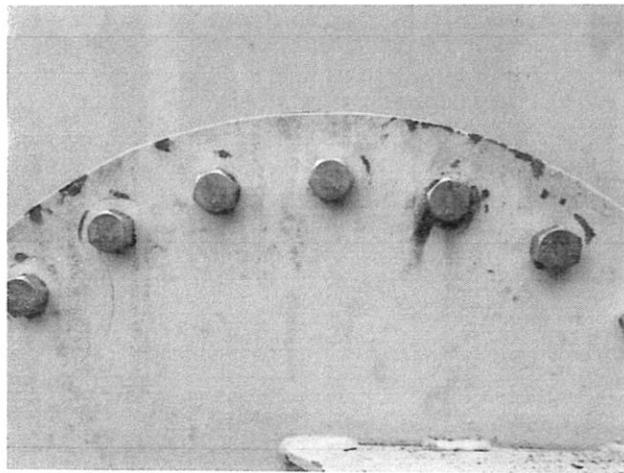
The protective coating applied to the steel surfaces of the northernmost manway was found having mostly good adhesion value and having an average dry film thickness of 19.7 mils, yet isolated areas of coating loss and steel exposure were observed throughout less than 5% of the manway lid.

No obvious fatigue (pitting) of the steel was evident within these 1/4" diameter to 1/4" wide by 1" long areas of steel exposure, rather mild surface corrosion exists at this time.

17 *Northernmost Manway With Coating Loss, Exposed Steel And Mild Surface Corrosion*

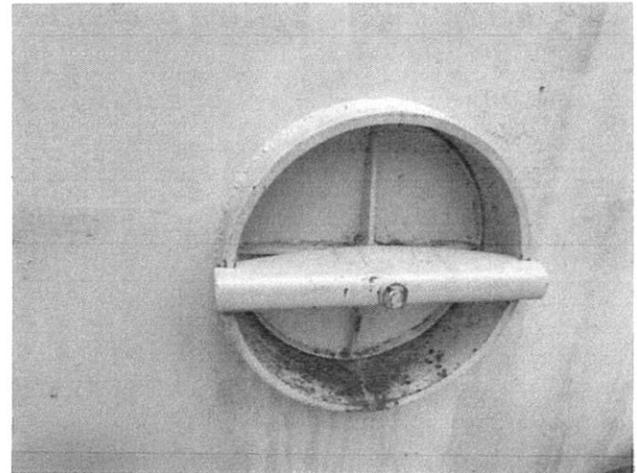
18 *Southernmost Manway*

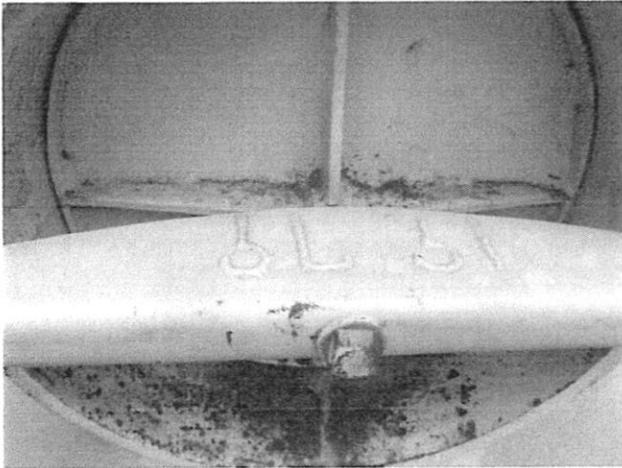
The protective coating applied to the steel surfaces of the southernmost manway was found having mostly good adhesion value and having an average dry film thickness of 7.9 mils, yet isolated areas of coating loss were observed throughout less than 5% of the manway lid, securing bar and trunk at this time.

No obvious fatigue (pitting) of the steel manway lid, securing bar, or trunk was evident within these 1/4" diameter to 1/4" wide by 1" long areas of steel exposure, rather mild surface corrosion exists at this time.

19 *Southernmost Manway With Coating Loss, Exposed Steel And Mild Surface Corrosion*

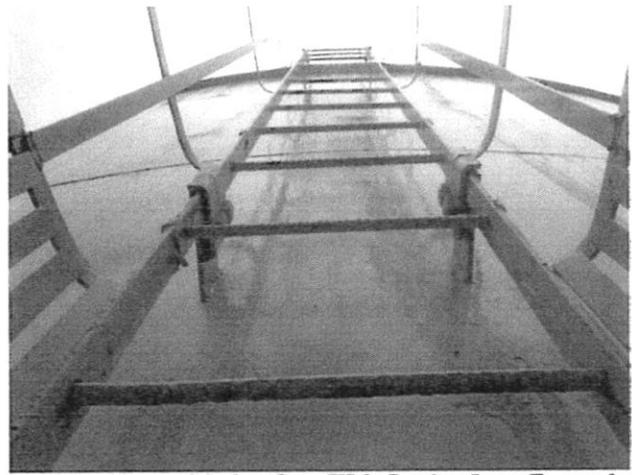
The protective coating applied to these surfaces was found having fair adhesion value, while isolated areas of coating loss and steel exposure were observed throughout less than 5% of the ladder and safety cage, resulting in exposure of the underlying steel.

No obvious fatigue or deterioration of these steel surfaces was evident within the areas of steel exposure, rather mild surface corrosion and corrosion staining exists at this time.

20 *Ladder And Safety Cage With Coating Loss, Exposed Steel, Mild Surface Corrosion And Corrosion Staining*

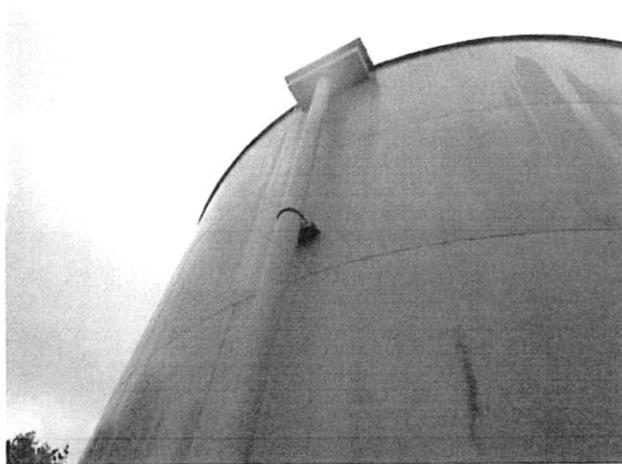
21 *Overflow Pipe And Weir Box*

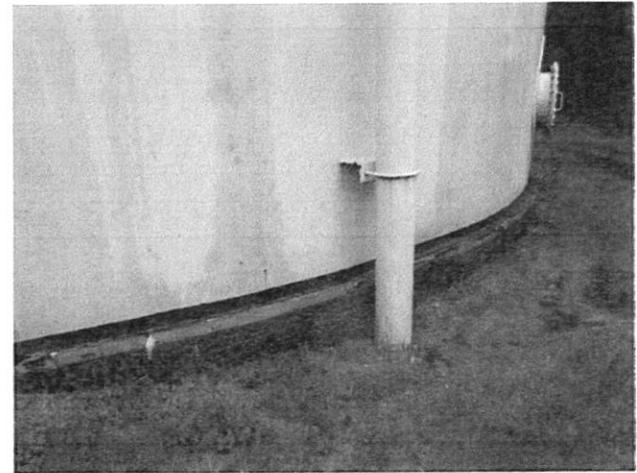
22 *Overflow Pipe*

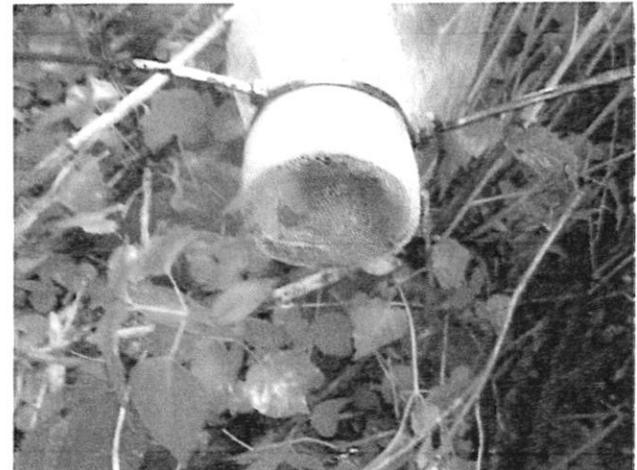
This pipe was free of obvious obstructions and was found with a screen installed at its end, preventing access to the interior of the pipe/tank.

24 *Screened Overflow Pipe*

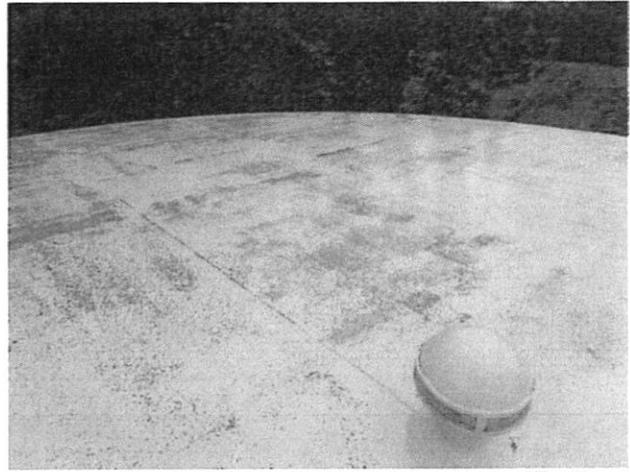
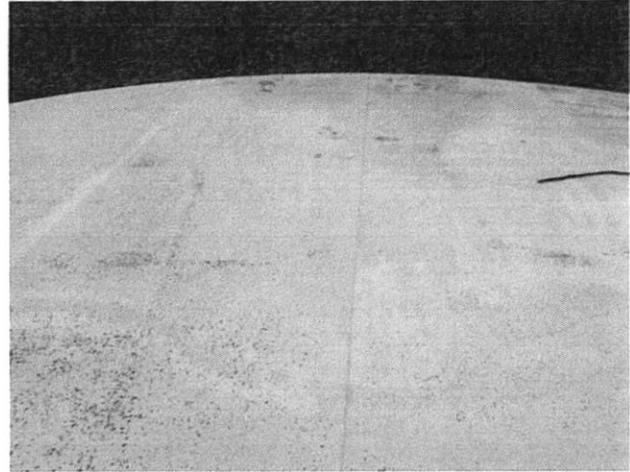
26 *Roof Dome With Secondary Coating Expired/Peeling
And Exposed Primary Coating*

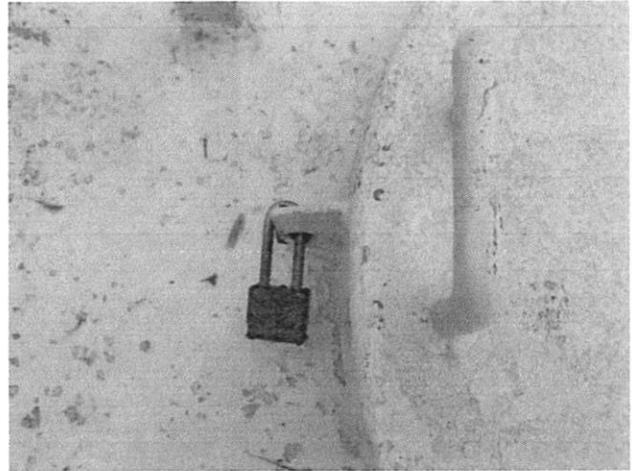
One 24" inside diameter steel hatch provides access to the tank interior through the roof. This hatch remains in good working condition and was found secured with a lock, preventing unwanted access to the interior of the tank.

34 *Secure Access Hatch*

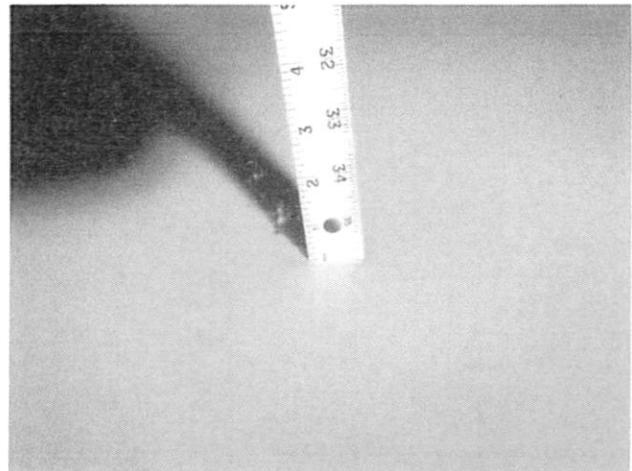
A uniform layer of precipitate was found throughout the floor, averaging 1/8" in depth.

36 *Layer Of Precipitate*

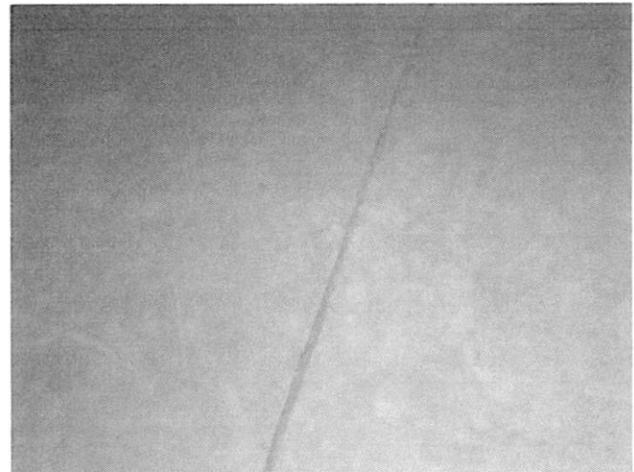
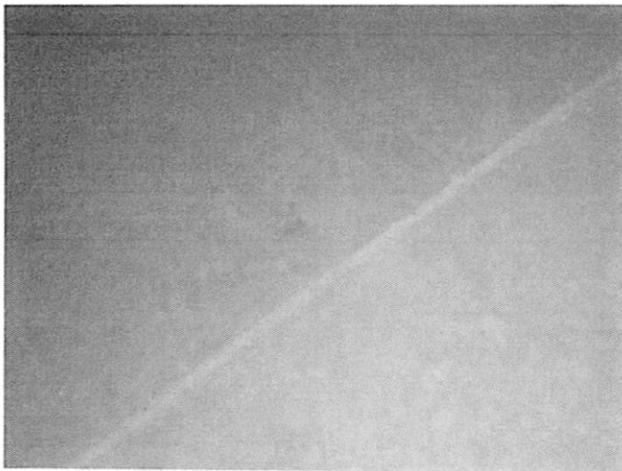
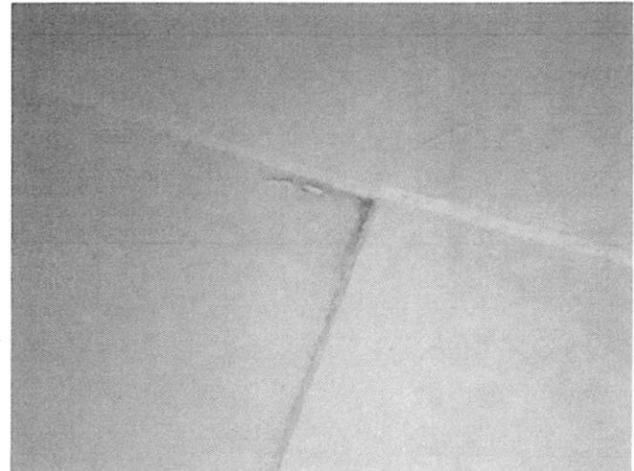
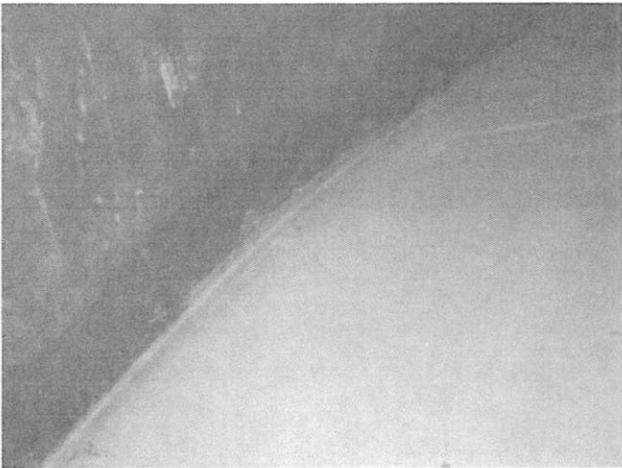
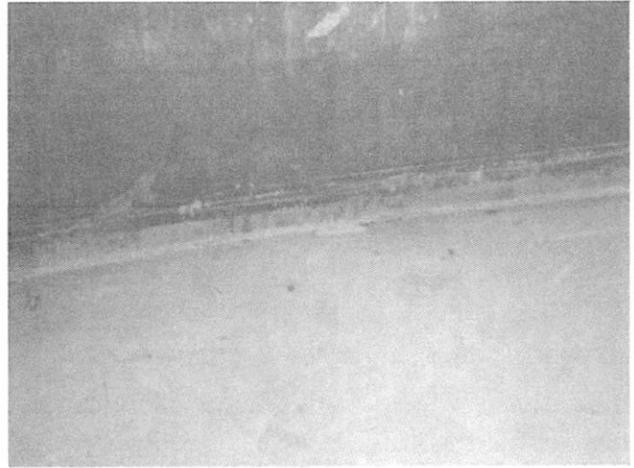
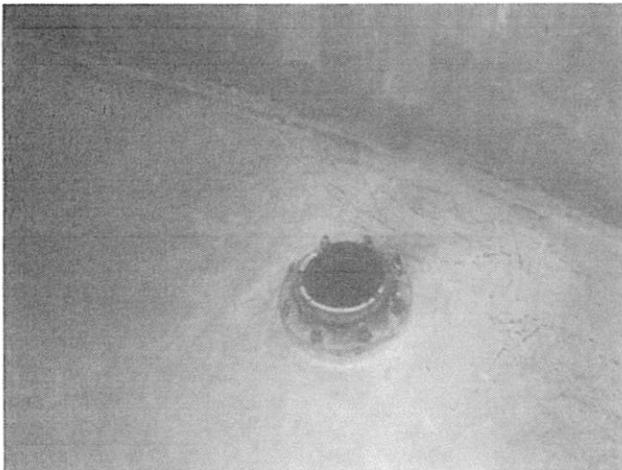
Mild staining exists throughout the floor due to the accumulation of precipitate.

39 *Floor With Mild Staining*

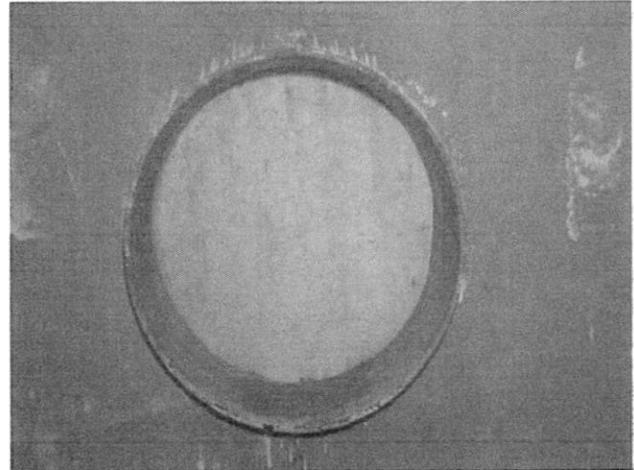
46 *Northernmost Manway*

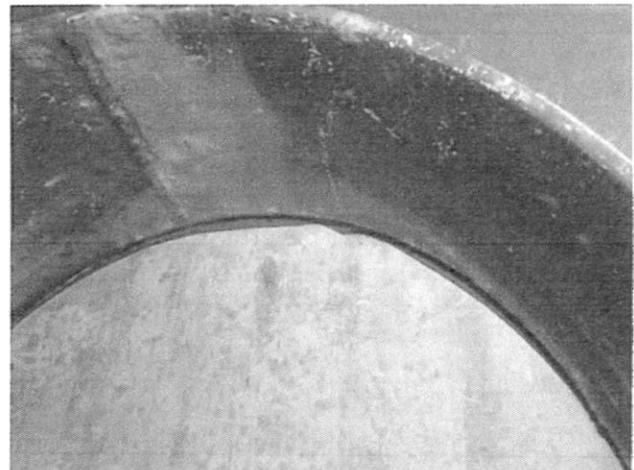
The protective coating applied to these steel surfaces was found having an average dry film thickness of 14.7 mils and is blistering throughout approximately 40% of these surfaces, while none of these blisters have ruptured and no obvious exposure of the underlying steel was evident at this time.

48 *Northernmost Manway With Coating Blistering*

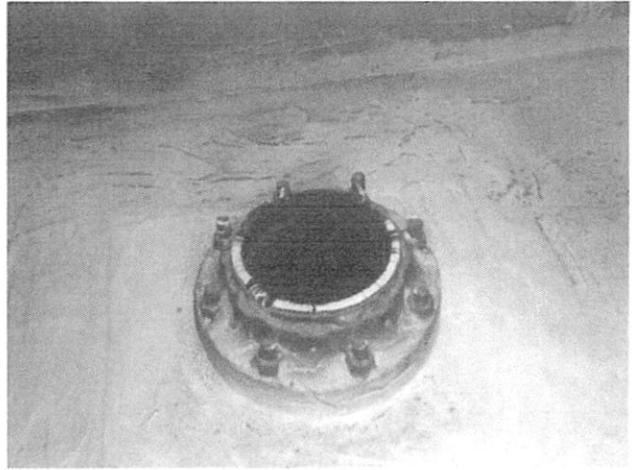
50 *Influent/Effluent Piping*

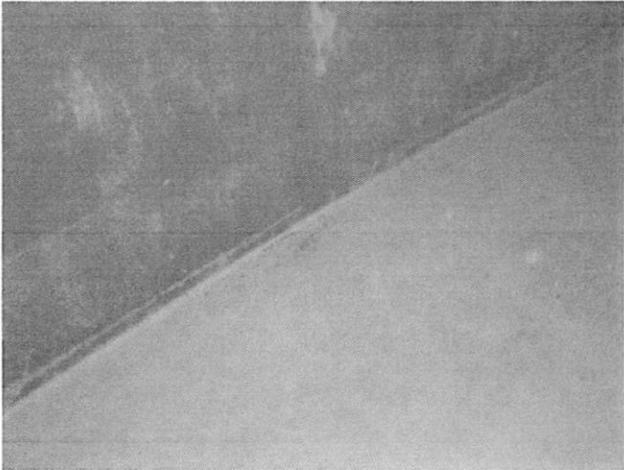
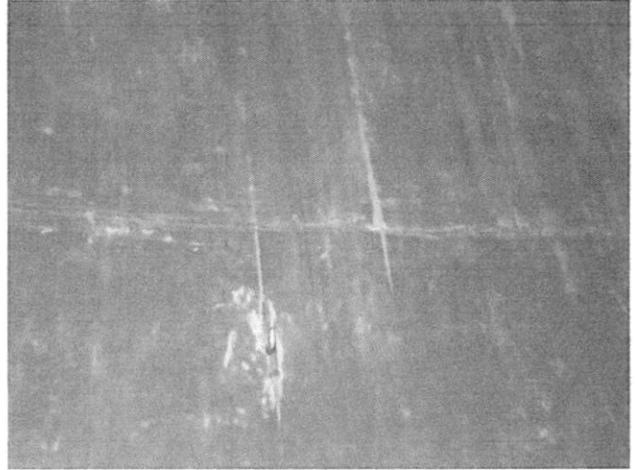
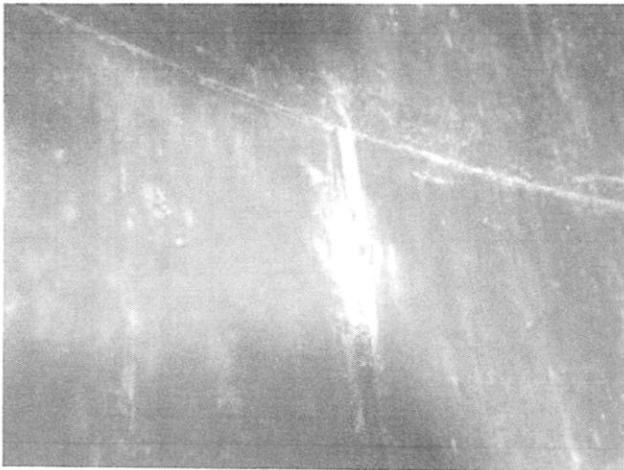
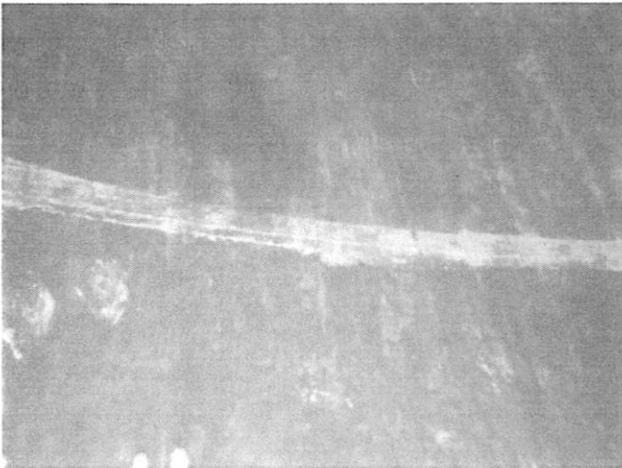
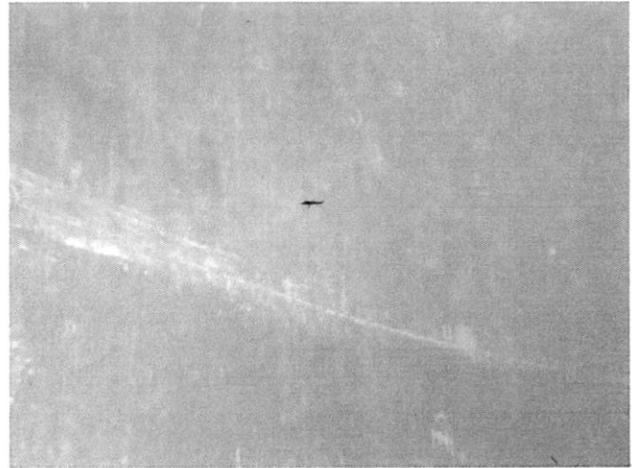
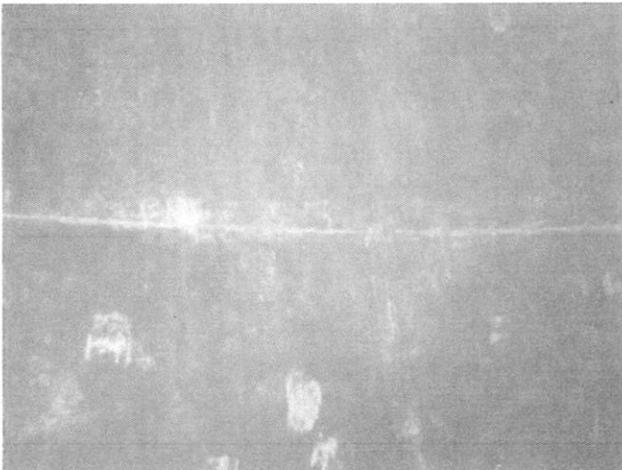
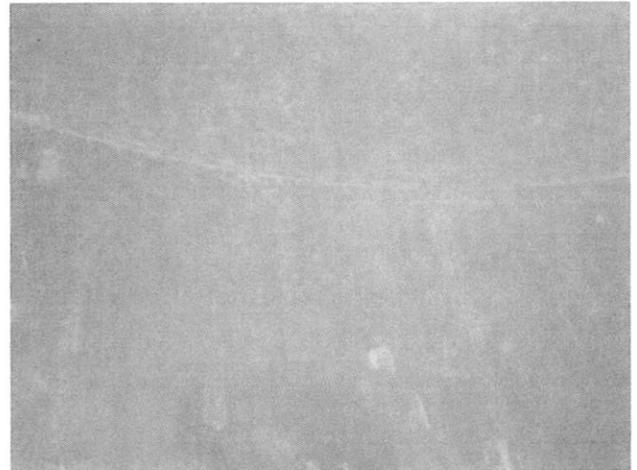
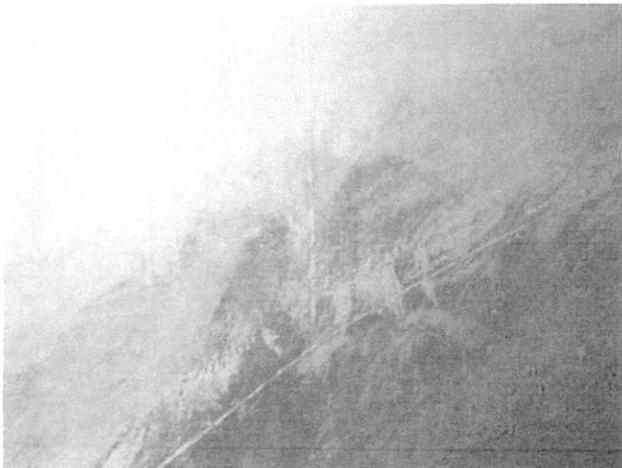
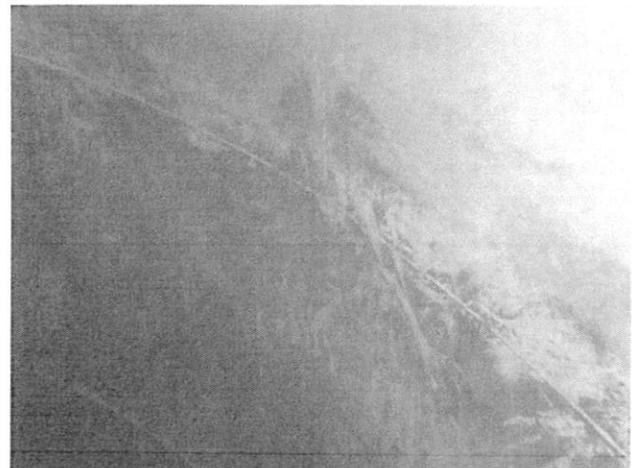
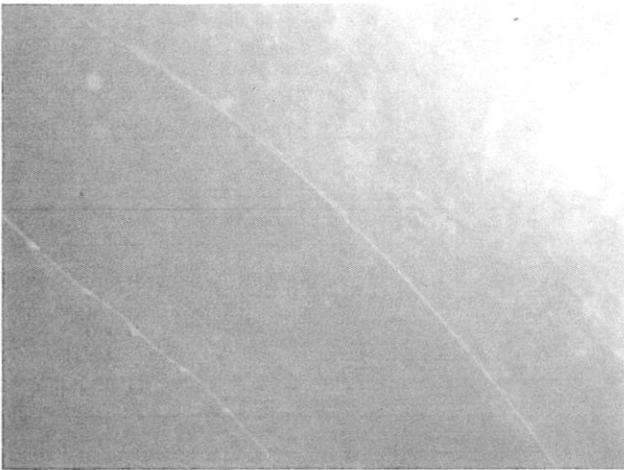
Mild staining exists throughout the interior walls, beginning approximately 60" below overflow level and extends down to the floor.

51 *Interior Wall With Mild Staining*

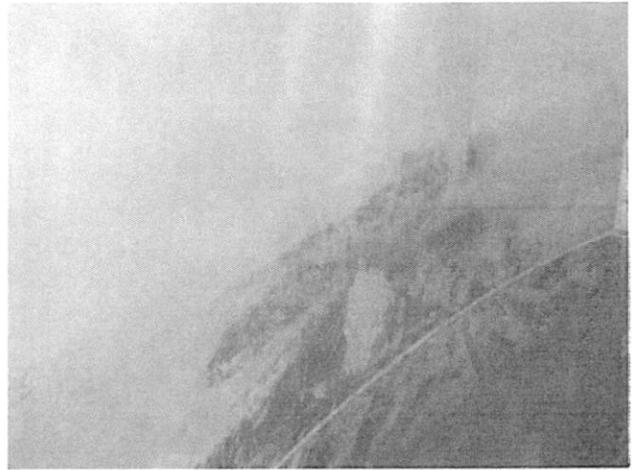
The protective coating applied to these welded steel surfaces was found having good adhesion value throughout the three lowest rows of wall panels, while four areas of secondary coating loss and primary coating exposure were observed throughout the top row of wall panels.

62 *Interior Wall With Secondary Coating Loss, Exposed Primary Coating And Mild Staining*

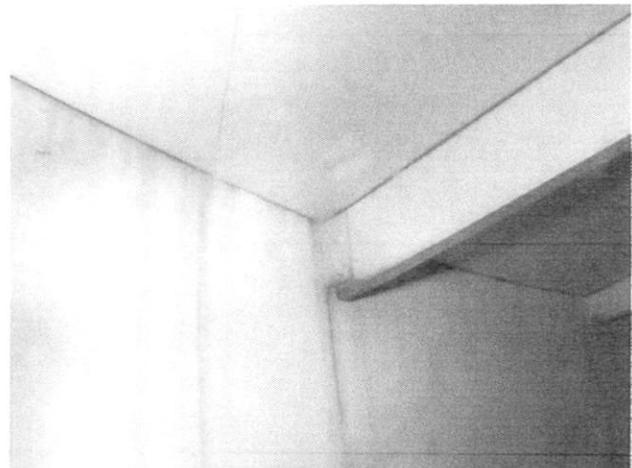
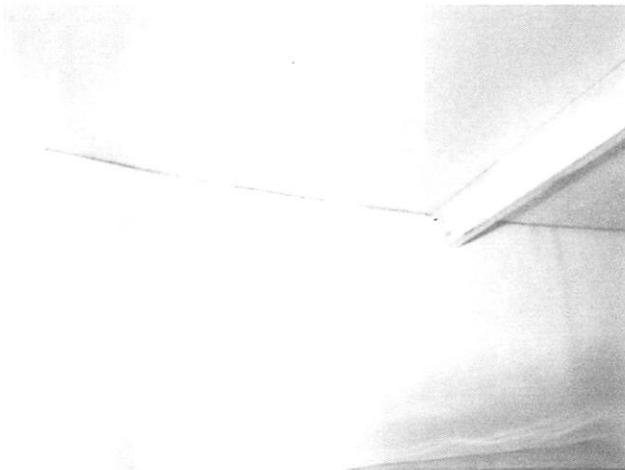
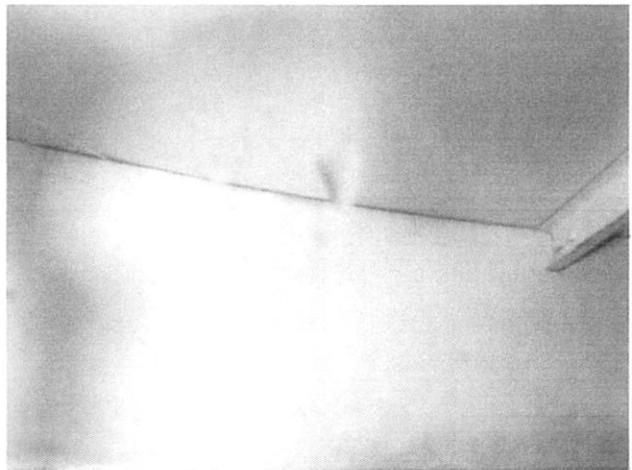
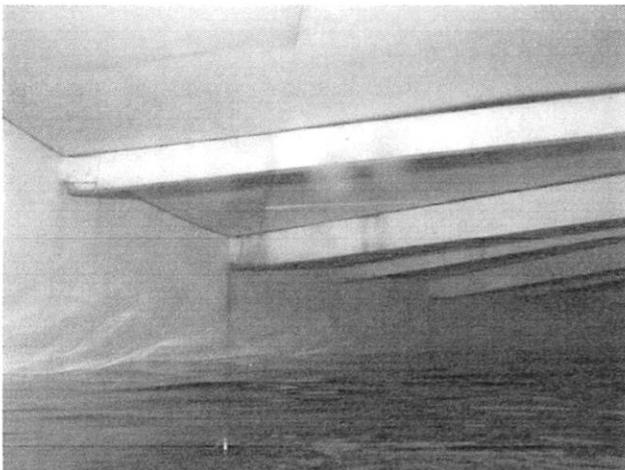
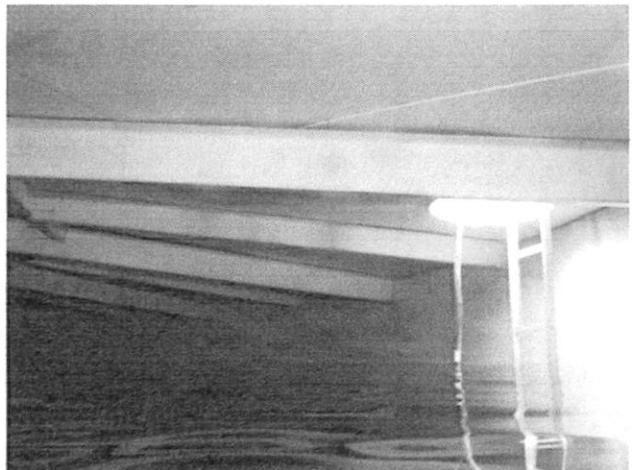
Mild rusting was observed throughout the circumference of the tank at the junction of where the roof and walls meet, yet no obvious exposure of the underlying steel was evident at this time.

66 *Interior Wall With Mild Rust Staining Where The Roof And Walls Meet And Mild Staining*

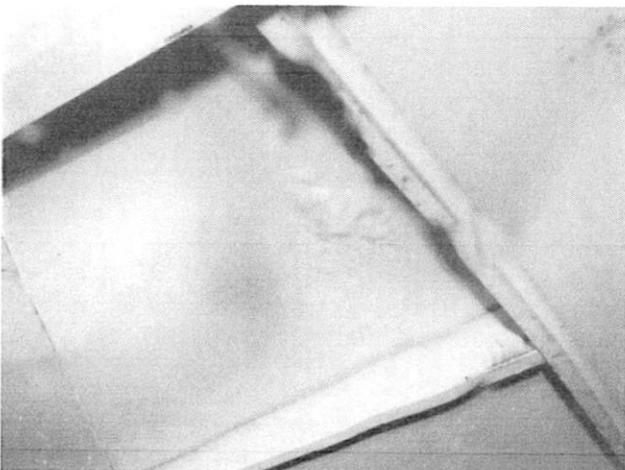
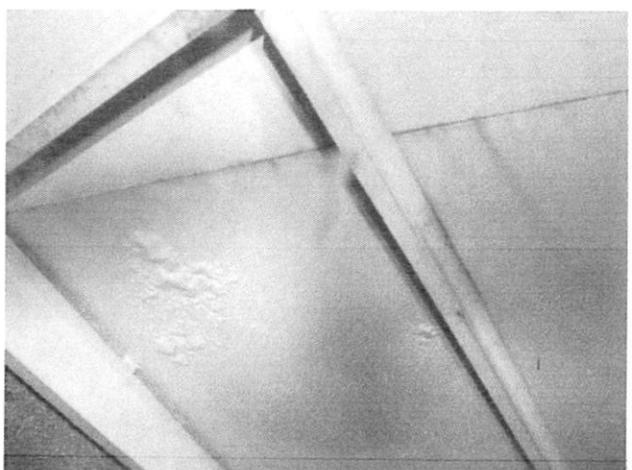
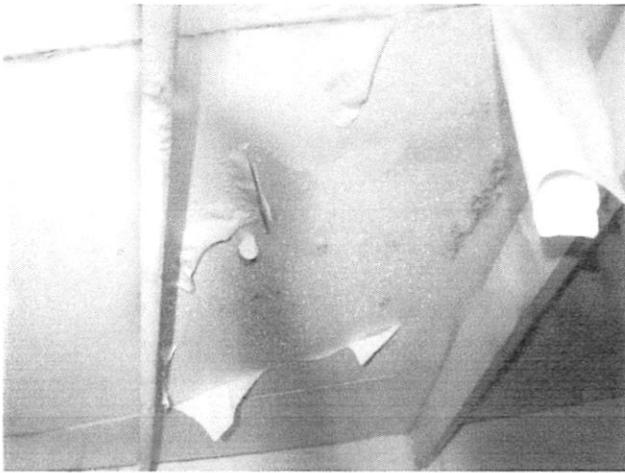
71 *Overhead With Coating Blistering, Secondary Coating Loss, Exposed Underlying Primary Coating And Blotch Rusting*

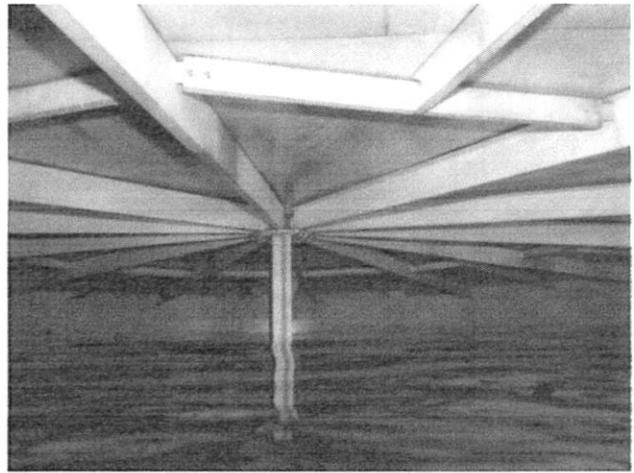
74 *Overhead With Blotch Rusting*
