TOWN BOARD OF THE TOWN OF LIBERTY-SPECIAL MEETING FOCUS MEDIA
120 NORTH MAIN STREET, LIBERTY, NEW YORK 12754
JUNE 27, 2016
7:00 P.M.

Mr. Peter Connery and I conducted a routine inspection of the Paramount Pond Dam, an intermediate hazard dam, on June 16, 2016 as part of the Department of Environmental Conservation's (Department) ongoing Dam Safety program. I am writing you as it is my understanding that you are or represent the owner of Paramount Pond Dam. A copy of the inspection report is enclosed.

***INSPECTION AND CLEANING (SEDIMENT REMOVAL) OF THE WHITE
SULPHUR SPRINGS 300,000-GALLON WELDED STEEL WATER
STORAGE TANK***

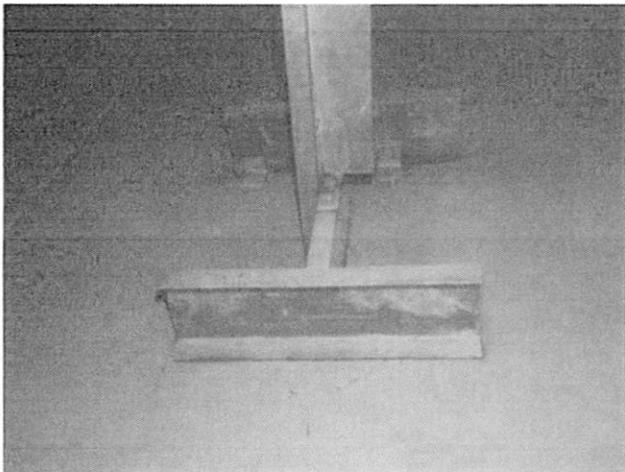
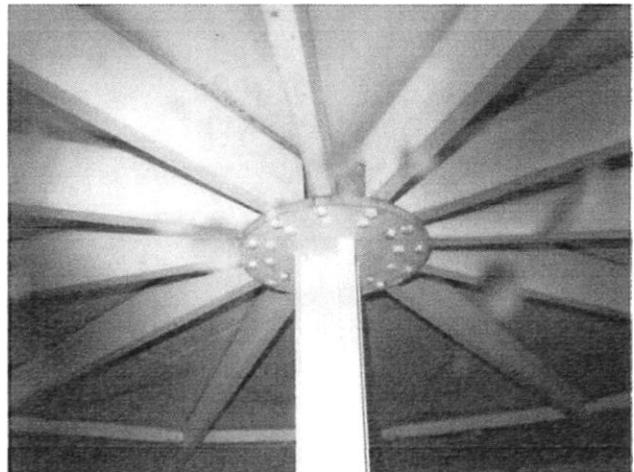
75 *Support Column*

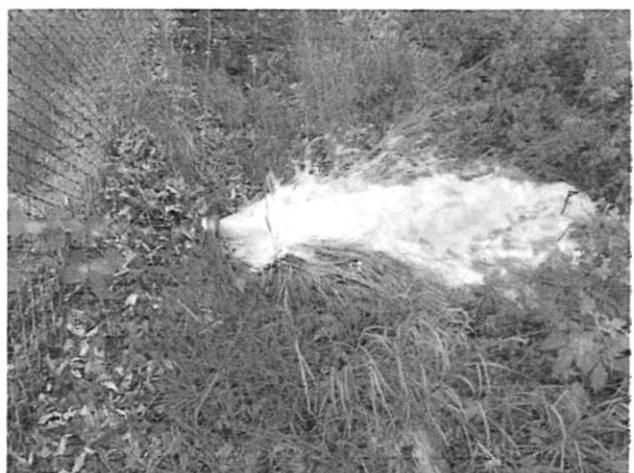
78 *Discharge During Cleaning*
