TOWN BOARD OF THE TOWN OF LIBERTY-SPECIAL MEETING FOCUS MEDIA
120 NORTH MAIN STREET, LIBERTY, NEW YORK 12754
JUNE 27, 2016
7:00 P.M.

Mr. Peter Connery and I conducted a routine inspection of the Paramount Pond Dam, an intermediate hazard dam, on June 16, 2016 as part of the Department of Environmental Conservation's (Department) ongoing Dam Safety program. I am writing you as it is my understanding that you are or represent the owner of Paramount Pond Dam. A copy of the inspection report is enclosed.

***INSPECTION AND CLEANING (SEDIMENT REMOVAL) OF THE WHITE
SULPHUR SPRINGS 300,000-GALLON WELDED STEEL WATER
STORAGE TANK***

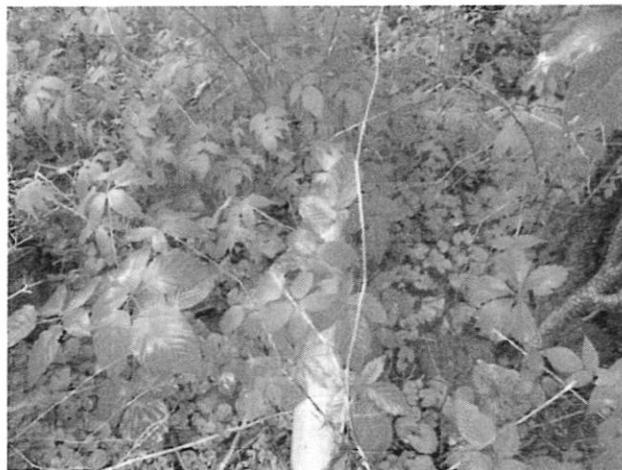
23 *Overflow Pipe*
